**Historic Building Condition
Survey Report**
of
WM. CURTIS NOYES ENGINE HOUSE
Castleton-on-Hudson, New York

Prepared by
LANDMARK CONSULTING LLC

Fall/Winter 2019

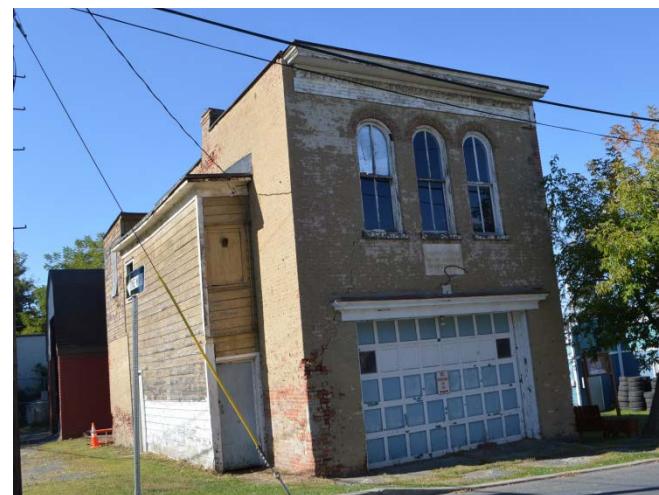
Figure 1: View of northeast corner of building showing front elevation & side stair structure.

Overall, the brick walls are plumb and sound however, there is a visible settlement crack at the front NE corner that should be addressed and the brick walls of the rear SW interior corner should be fully repointed with loose, broken/spalled or missing bricks replaced. The conditions that have contributed to the deterioration, notably inadequate roof drainage, overgrown vegetation, and use of deicing salts near the walls should be corrected.

- Raking crack on NE corner pier to be inspected by structural engineer to assess full cause and design repair. Likely caused by ground settlement and changes in masonry openings related to modern garage door.

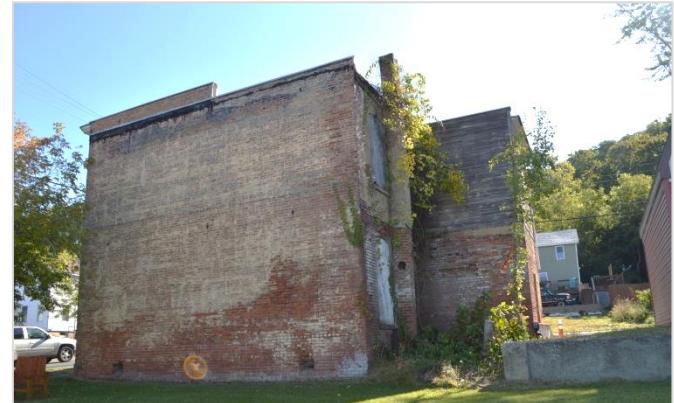
On the west elevation, there are no windows or door openings aside of small rectangular vent holes at the first floor level. The brick wall is fully exposed and the lower 5-feet of wall is bare of most of its paint finish. The only elements of note on this elevation are the three diamond shaped tie-rod anchor plates aligned approximately with the second floor plate. There is some extent of mortar wash out where brick coursing need repointing or there are a few brick units that have dislodged or shifted around the lower vent openings.

Figure 2: View of west elevation showing masonry walls.

- Openings in foundation wall on west elevation where bricks have become dislodged should be carefully infilled with new masonry units and mortar.
- Exterior applied brick chimney on rear (south) elevation no longer serves a purpose and yet is conducting water down face and into wall. Chimney should be carefully dismantled, brick salvaged for reuse or repairs.

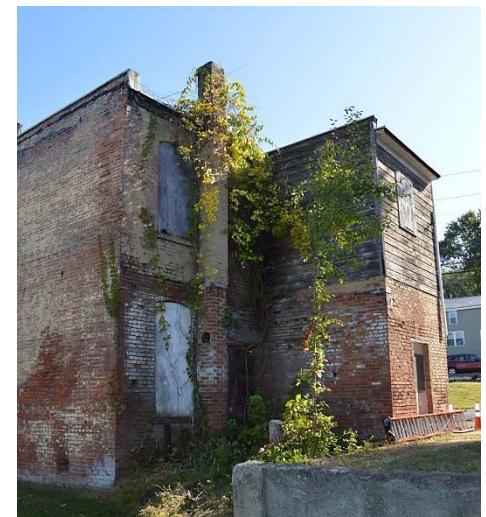
Figure 3: View of southwest corner of building.

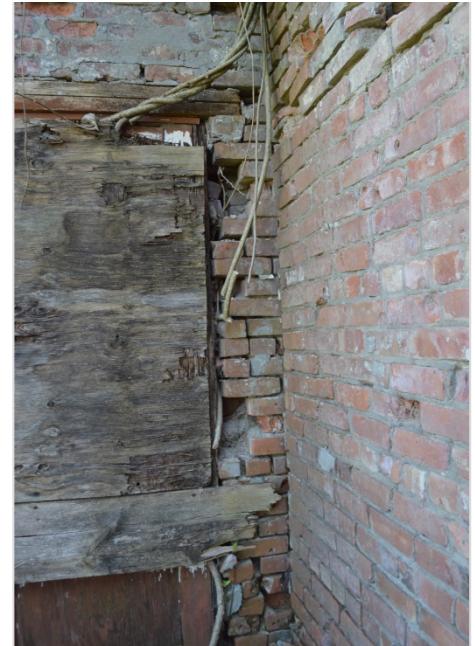
There is visible evidence on this south wall of the main building as well as on the west elevation of the ell, of previous roof flashing at the one story level, but no evidence of wall or roof framing connections to either wall. This suggests that the space between the main building and the ell was once enclosed with a later addition that was framed as freestanding and used the existing entry door as the internal connection. It is unknown when this addition was removed or what purpose it served. Overall the south brick wall is in poor condition with extensive mortar washout, cracked or missing brick units and is in need of repointing and repairs.

Figure 4: Detail of mortar & brick washout on inside corner of rear wall.

- Outer face of south wall to be carefully repointed with new brick units pieced in where missing, especially in SE corner and around door opening. West wall of south ell to be carefully rebuilt where brick courses are bulging/bowing outward, bricks have cracked or spalled or are missing altogether.

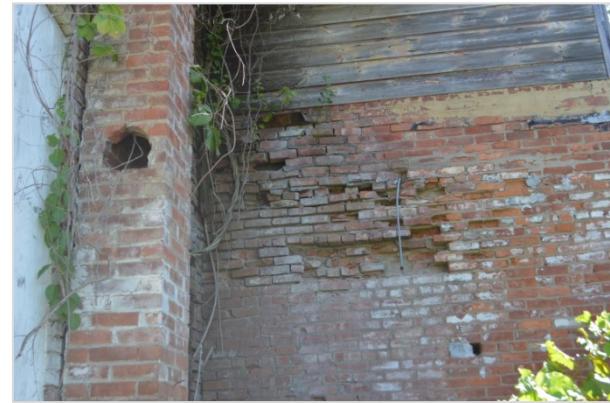
The west wall of the ell is exhibiting the most severe masonry conditions. The brick coursing at the corner of this juncture of main building and ell has extensive mortar wash-out and as a result loose or dislodged brick units. At the upper 20 courses of brick on the west wall of the ell there is extensive bulging of the outer brick wythes, spalled brick units, and numerous dislodged and missing bricks. There appear to be a number of causes impacting this severe condition. First, the roof of the main building is a low slope roof pitched from the front toward the rear without any rear cornice gutter to catch and divert rain water or snow melt.

Secondly, the chimney and lack of vegetation control have contributed to the growth over a long period of wall climbing vines that has attracted, absorbed and retained moisture against this interior corner and caused extensive mortar deterioration. Lastly, it appears that the existing EPDM rubber membrane roof on the main building and ell including the parapets was installed in the last decade, and prior to this, water was directed from the main roof right onto the parapet wall of the ell and likely infiltrated down through the wall cavity and into the brick wall. Freeze and thaw action of a water saturated brick wall, covered with vegetation is what likely led to the bulging and partial collapse of the upper west wall of the ell and the interior corner. Previous pointing campaigns appear to have used a hard Portland cement-based mortar which is too hard and impervious for the soft 19th century brick on this building. This has contributed to the extensive spalling noted around the large hole in the brick wall of the ell. This area of damage also appears to coincide with the location of the previous one story addition roof line and if there was a leak in this roof the brick damage could have gone undetected for some time.

Figure 5: Loss of brick on west wall of south ell.

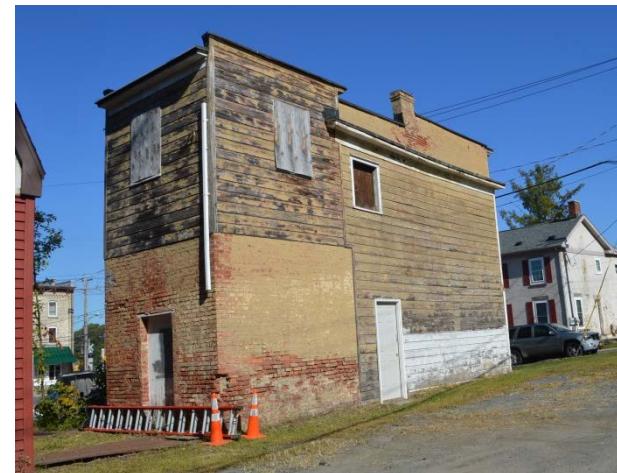
Figure 6: View of southeast corner of building.

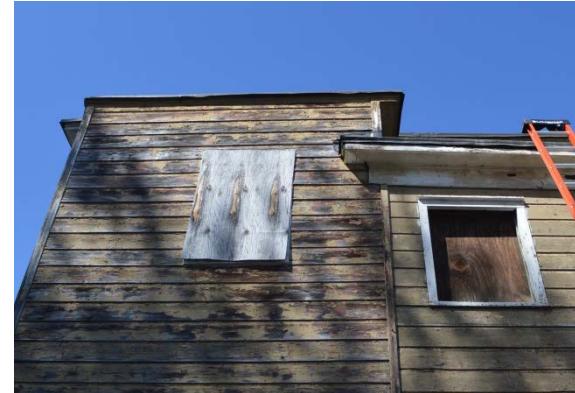
Figure 7: Junction of south ell & stair structure on east.

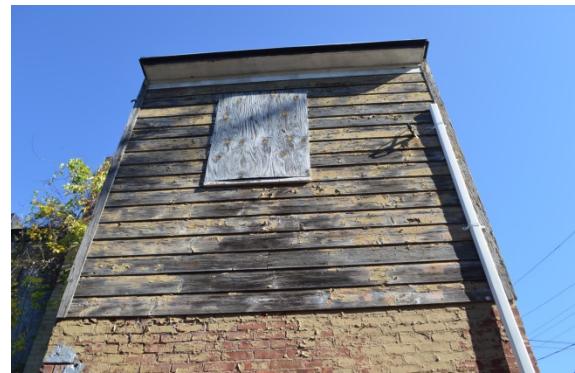
Figure 8: Second floor south elevation of ell.

- The wood walls of the second floor of the south ell and the stair structure on the east elevation are in fair condition, but the wood is nearly bare of paint, with wood grain open and exposed to the elements. The wood clapboards, trim and cornices throughout the building exterior should be carefully scraped of loose paint, down to sound substrate, joints and seams secured with finish nails or trim-head screws, caulked, and primed and repainted with a minimum of two finish coats of quality exterior paint.
- Areas where wood elements (siding, trim or cornice) are exhibiting extensive punkiness or wood decay, or where it is missing altogether, the wood element should be replaced in-kind to match dimensions, profiles, and surface finish. Wood species to match or exceed in durability all sides primed.

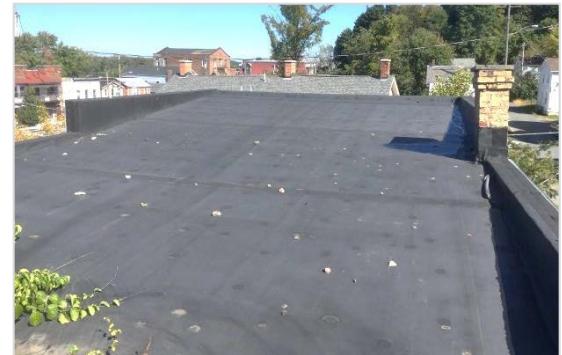
Figure 9: View of main roof looking north.

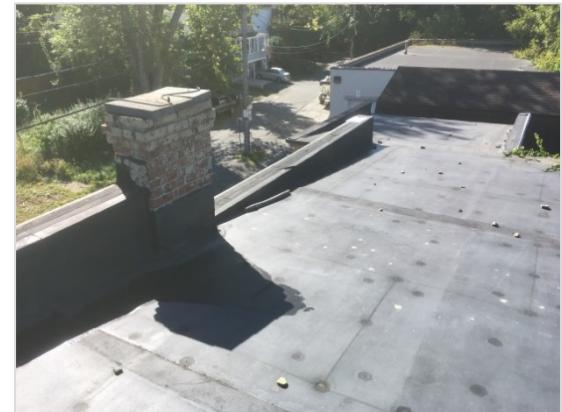
Figure 10: View toward east side parapet walls.

- Pointing of the parapets walls particularly around the original east chimney is needed to ensure a water- and weathertight assembly.
- Full west, south and east walls of south ell to be repointed with inappropriate mortar (Portland cement) campaigns removed. Pointing mortar to be softer than brick units so as to ensure it won't result in spalling or damage of soft bricks.

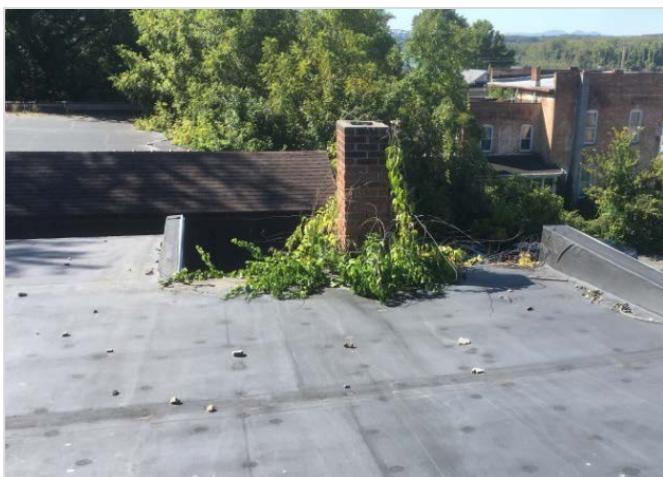
Figure 11: Roof from north side showing vegetation growing on rear chimney parapet walls.

- All vegetation attached or within 18" of the masonry walls should be removed including roots. This includes climbing vines and trees up the south wall of the building. Care to be taken in pulling off or removing vines from brick surfaces, as roots or tendrils may have secured themselves deep within mortar joints and can cause brick to pull out.

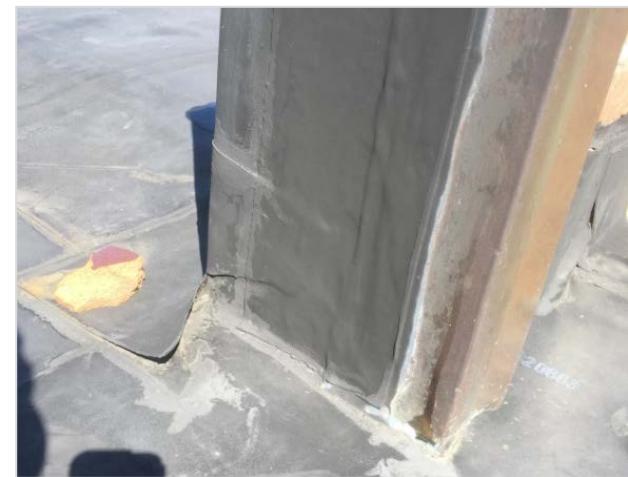
While attempted to be adhered or sealed directly to the underlying membrane these perimeter strips are lifting at all edges and present a location for water entry. Despite being considered a redundant roofing layer, leaks and water infiltration points could be concealed and undetected under the loose flaps of these strips.

**Figure 12: Detail of EPDM flashing up against parapet.
Note lifted seam.**

- Regular roof inspections to ensure that seams in the EPDM membrane should be conducted. While the roof appeared to be watertight during our on-site assessment, there are loose flaps or strips of EPDM membrane that were laid over drip edge materials and fasteners that were lifting and were a potential point of enter for water or snow melt.

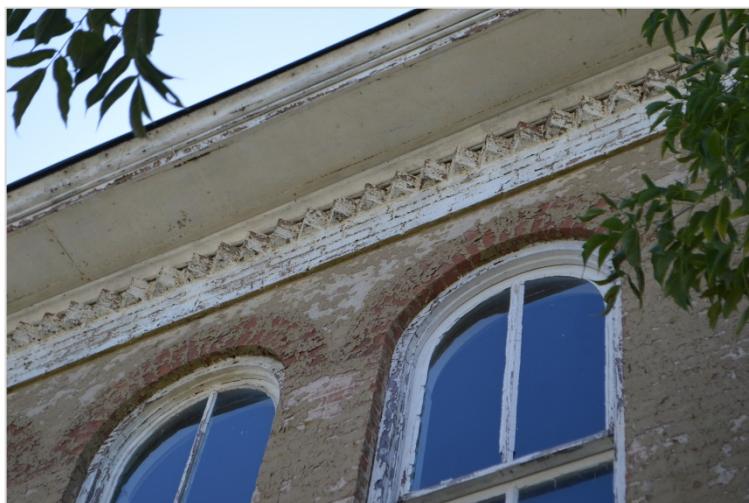
Figure 13: Original main cornice on front façade roof eave.

In all cases, the wood cornices are in fair condition but are exhibiting paint failure as a result of water drainage and exposure to the elements.

- Typical of other wood trim elements, the built-out wood cornices in all locations around the building exterior simply are in need of repairs to the paint finish and strengthening of the wood joinery.

- Where mitered corners at ends of each cornice are separated, opened or exhibiting a gap between wood elements, these pieces need to be reinforced, secured tightly and sealed with silicone-based caulk to prevent any water infiltration that can later lead to wood rot.

- Loose paint should be carefully scraped away down to bare wood or sound substrate, reprimed with penetrating oil-based paint, and given a minimum of two coats of quality finish paint.

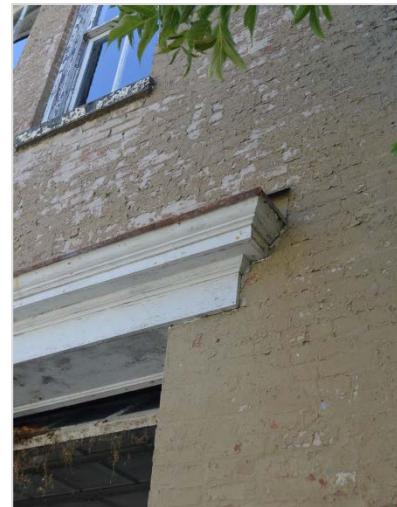
Figure 14: New cornice over garage door opening.

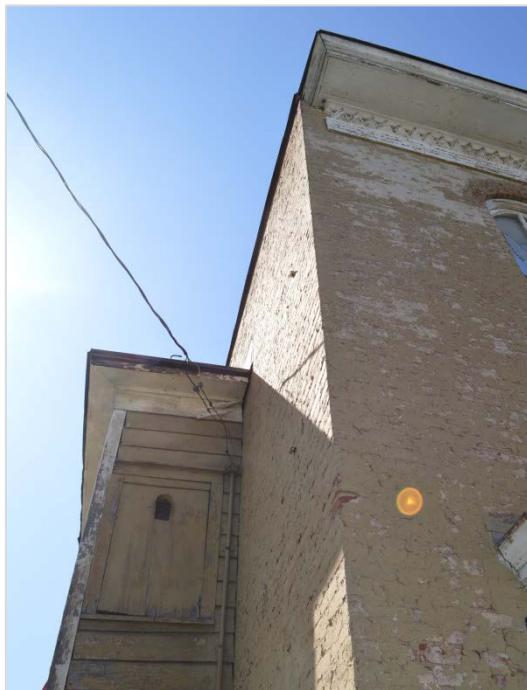
Figure 15: Simply eave cornice at stair structure (left).

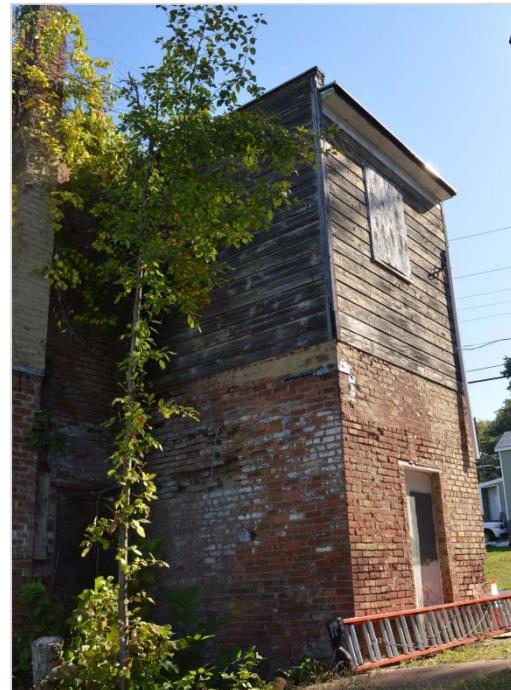
Figure 16: Simple eave cornice on rear (south) of ell.

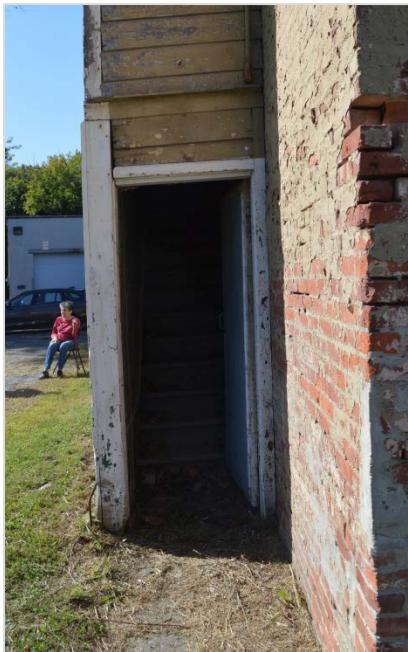
Figure 17: Doorway to stair structure on north elevation.

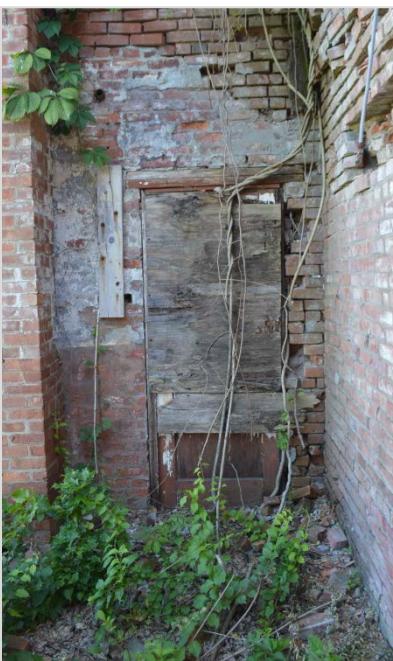
Figure 18: Boarded up door on south elevation.

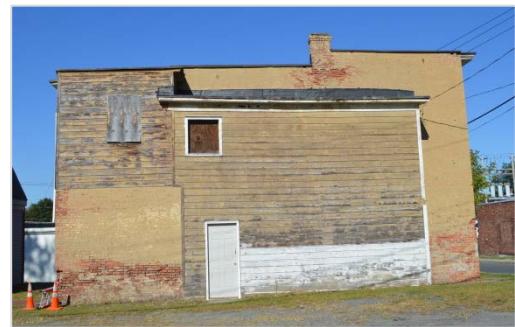
Figure 19: New door on east side entry of stair structure. (above)

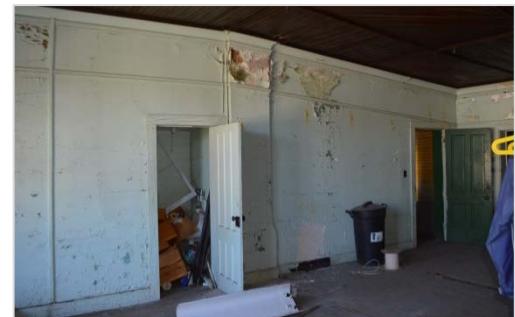
The second floor doors are in good and functional condition. On the ground floor, ideally all four entry doors should be functional and in good physical condition. The doors on the south wall of the main building and the north wall of the stair structure should be restored to include their glazed upper panels, perhaps with tempered glass for security reasons.

Figure 20: View of interior second floor doors. (below)

- Interior historic doors are in good condition and simply require paint refurbishment in conjunction with finish repairs in each space. Most doors include original/historic rim locks, hinges with pins and ceramic knobs. These should be carefully retained, repair or cleaned up where necessary. Replacement parts can be found at local architectural salvage shops where needed.

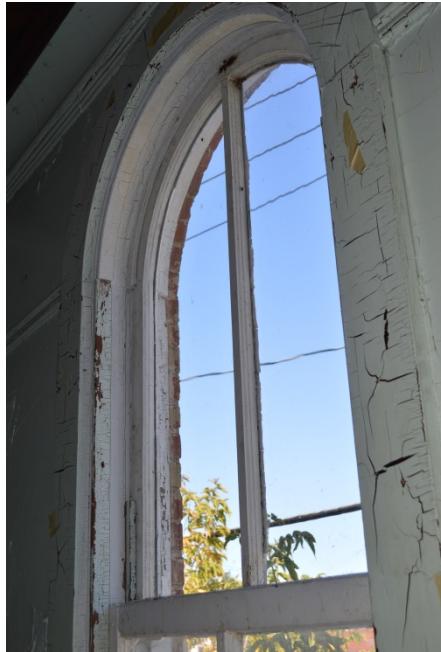
Figure 21: View of second floor round-top 2/2 window from interior.

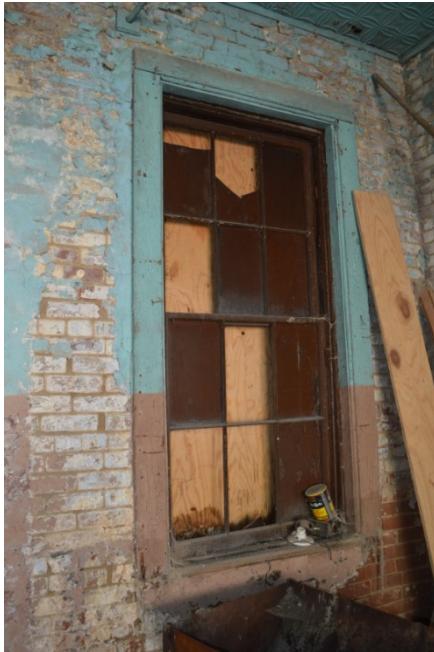
Figure 22: First floor boarded up 6/6 window from interior.

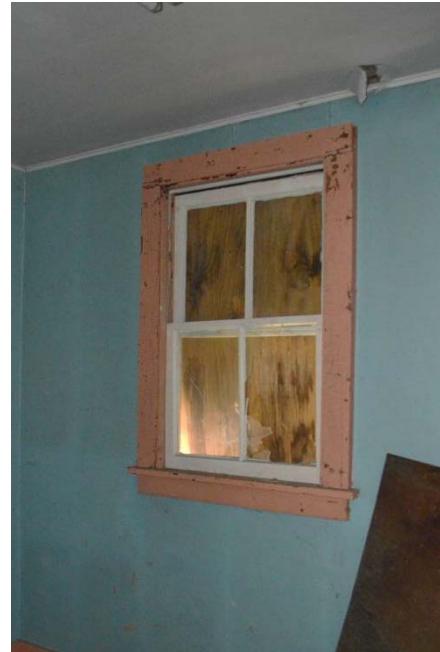
Figure 23: Boarded up 2/2 window in south ell from interior.

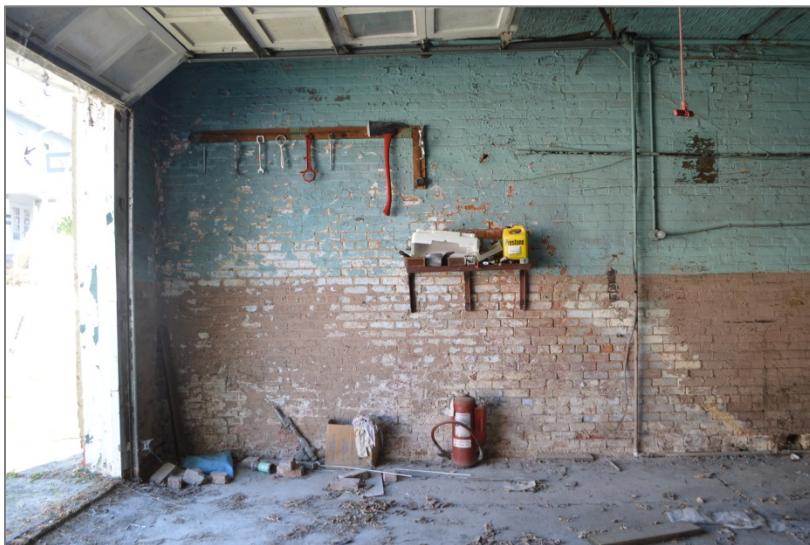
Figure 24: View of garage space east wall finishes – painted brick.

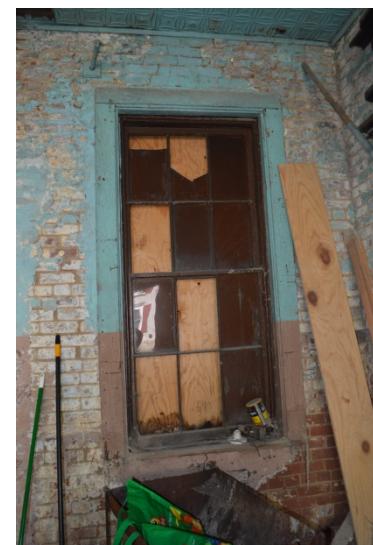
with the extent of roof drainage issues on the exterior side of this wall that the plaster finish has not survived. Similarly the paint coatings on the exterior walls are exhibiting failure and loss of adhesion with extensive cracks, alligatoring and peeling. Without interior conditioning, perimeter masonry walls are subject to constant fluctuations in temperature and dampness and make it difficult to maintain a finish. The extent of peeling paint however gives a glimpse of the number of finish campaigns over the past century and a half. Paint ghost lines also provide evidence of locations of shelving, utility equipment and changes to masonry openings. The garage space is currently painted with a horizontal division of the walls with the lower four feet painted one color and the upper half painted another. The jail cell room in the south ell has a plaster finish applied directly to the brick walls that is for the most part intact. There are cracks in this plaster, bulges/delamination, and extensive peeling of many paint layers. Despite the extensive brick failure on the exterior of the west wall, there is no evidence of extensive water damage aside from the loss of the plaster finish closest to the northwest corner.

Figure 25: South wall of garage space showing remnant plaster under window.

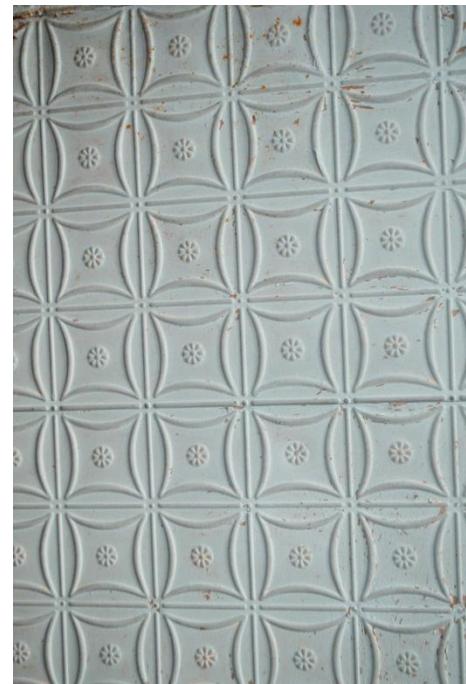
Figure 26: View of intact section of pressed tin ceiling in garage space.

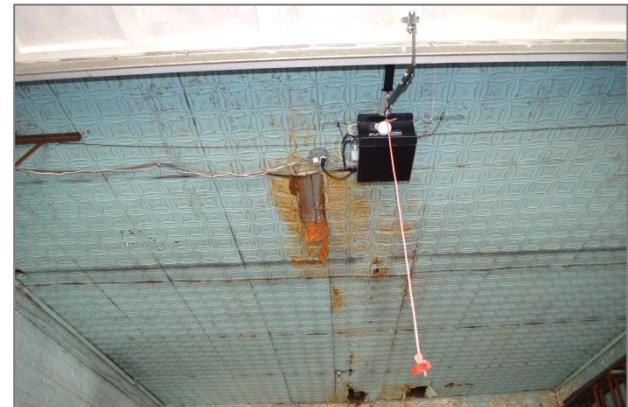
Figure 27: View of pressed tin ceiling in garage space showing rust at panel edges.

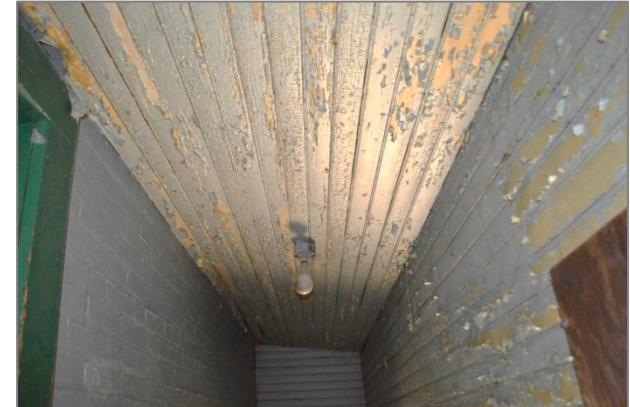
Figure 28: Beaded board ceiling & walls in Stair structure.

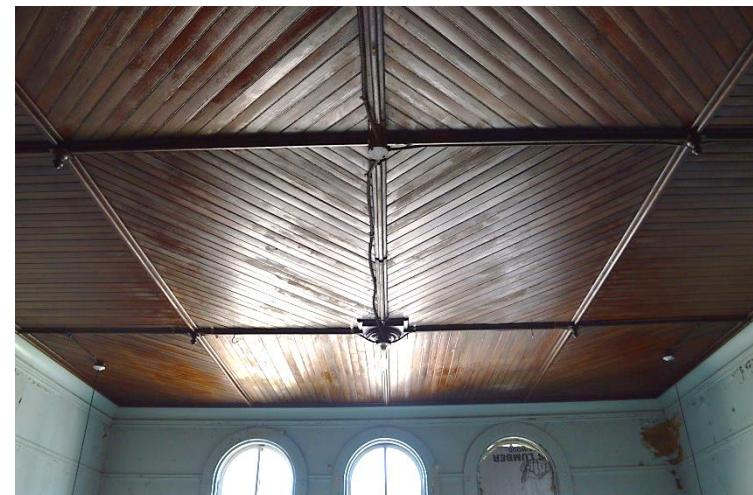
Figure 29: Patterned beaded board ceiling in second floor hall.

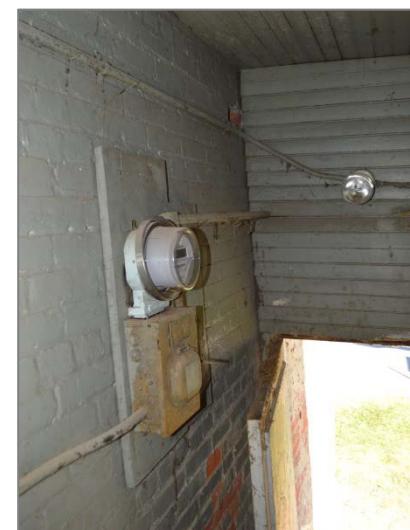
Figure 30: Electric meter & fuse box.

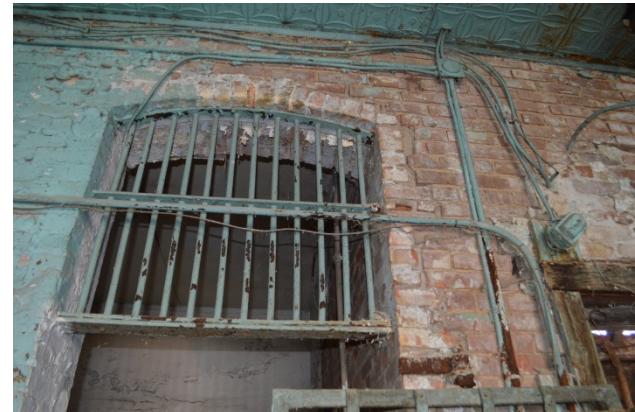
Figure 31: View of abandoned wires, conduits & junction boxes.

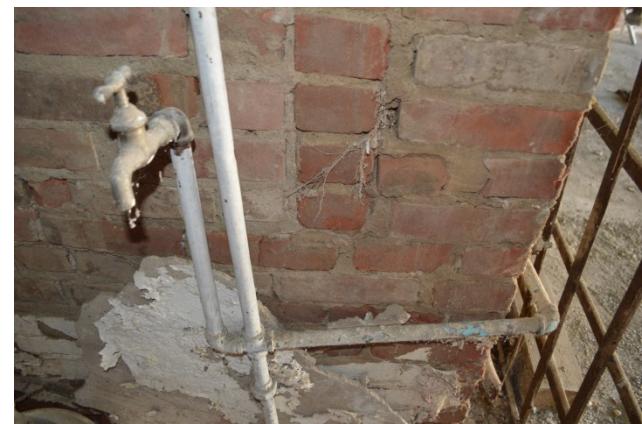
Figure 32: Example of abandoned plumbing in jail cell.

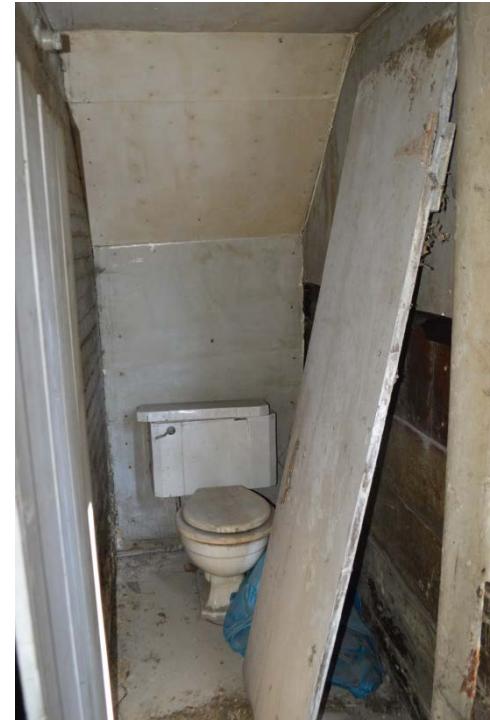
Figure 33: Circa 1930s toilet in bathroom under stair.
