**Historic Building Condition
Survey Report**
of
WM. CURTIS NOYES ENGINE HOUSE
Castleton-on-Hudson, New York

Prepared by
LANDMARK CONSULTING LLC

Fall/Winter 2019

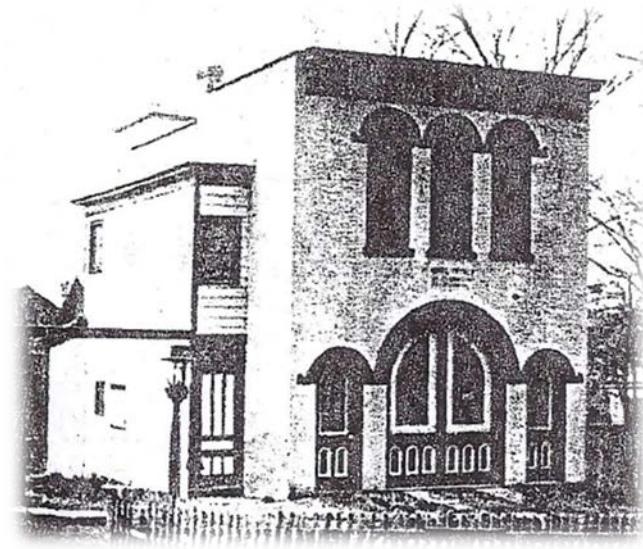
- As noted, the front elevation of the building was significantly different when first constructed. The ground floor of the north façade consisted of three consecutive arched openings. The center arch was broader and taller to accommodate two hinged garage/carriage-style doors for the first engine. One each flanking side were narrower, shorter single-leaf entry doors. All four doors had the same design with half-round tops, undivided upper panels, and multiple recessed vertical panels at the lower half (two on each entry door, and three on each of the carriage doors). The flanking doors appear to have glazed upper panels to allowed natural daylight into the ground floor space. When this was altered in the mid-20th century to accommodate larger, modern fire trucks, the arched openings were eliminated and replaced with a steel header and squared opening.

- If the intent is to restore this historic fire station for community/public programming purposes, it would ideal to reinstate the original arched door openings to match the second floor windows and replicate the design of the original doors. Sufficient photographic documentation exists to facilitate this design and restoration. Similarly based on interior programming of spaces, a case could be made to restore the configuration of the east wall of the stair structure with windows where they were once located.
